**SOLID AND HAZARDOUS WASTE MANAGEMENT BRANCH
COMPLIANCE ASSESSMENT**

SUBJECT: Compliance Assessment at Procino Plating FILE

GENERATOR/TSD LOCATION ADDRESS: 901 South Market Street
Seaford, Delaware 19973

PURPOSE OF ASSESSMENT: Follow-up Inspection (FUI) and Sampling

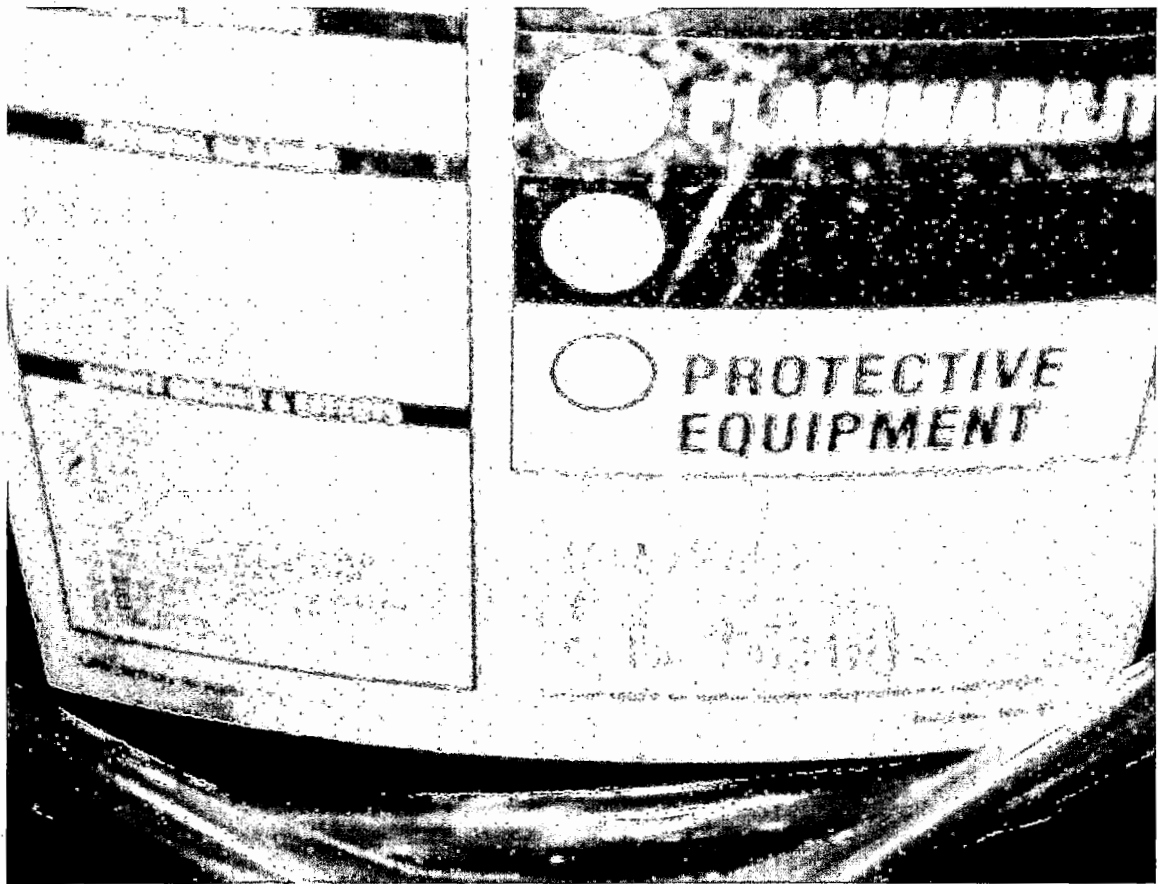
Photograph #1

Label on Container #7 containing spent brass plating bath solution indicating the waste is to be treated in the facility's on-site wastewater treatment unit. The facility stated in their July 27, 2008 response to EPA Region III's Information Request Letter (IRL) that this was good, usable material. However, on August 20, 2008, the label still indicates the drum contains a waste material.

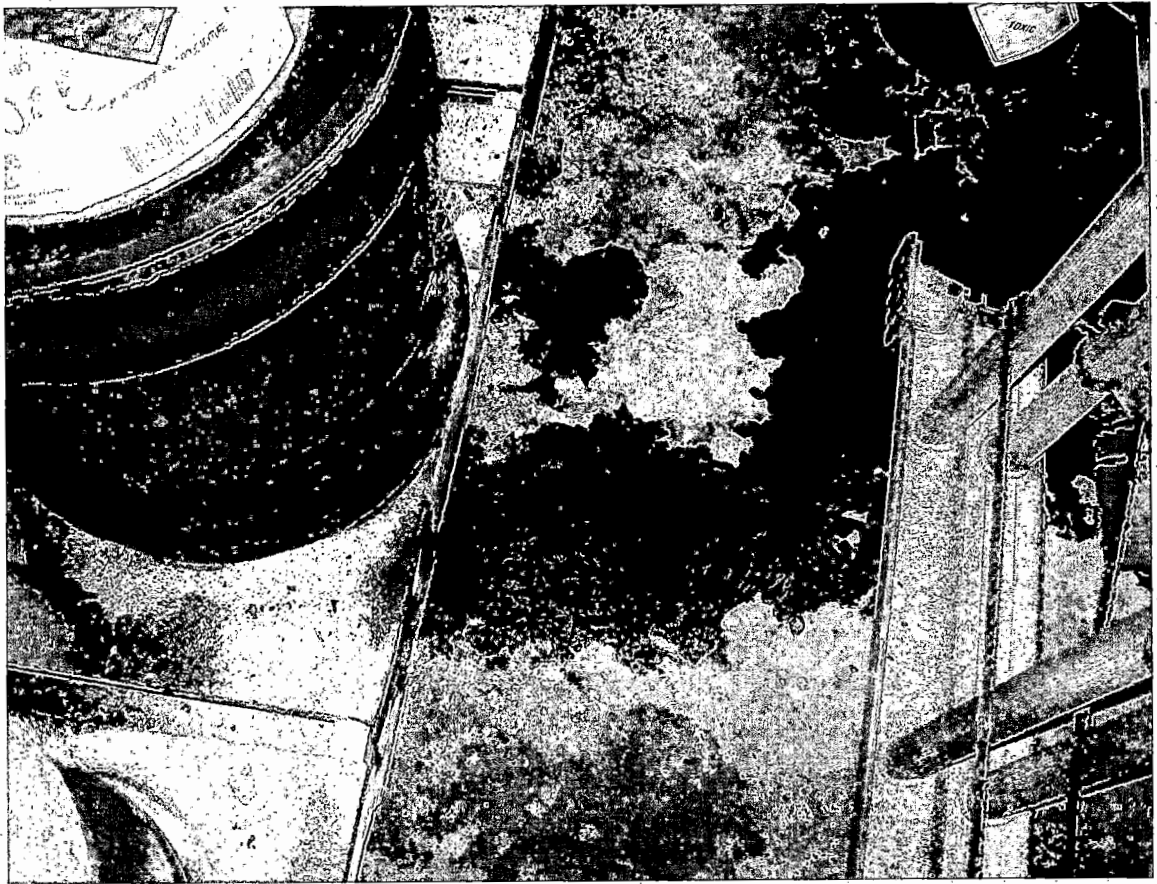
Photograph #4

SHWMB representatives observed an active leak black liquid (also shown in Photograph #3 above) on the concrete floor beneath the wooden pallet holding Containers 72-85 (Row 3). There were also several extremely rusted containers on this pallet, including containers of Iridite, Entek CU-55, Econo-chrome, and several unknowns.

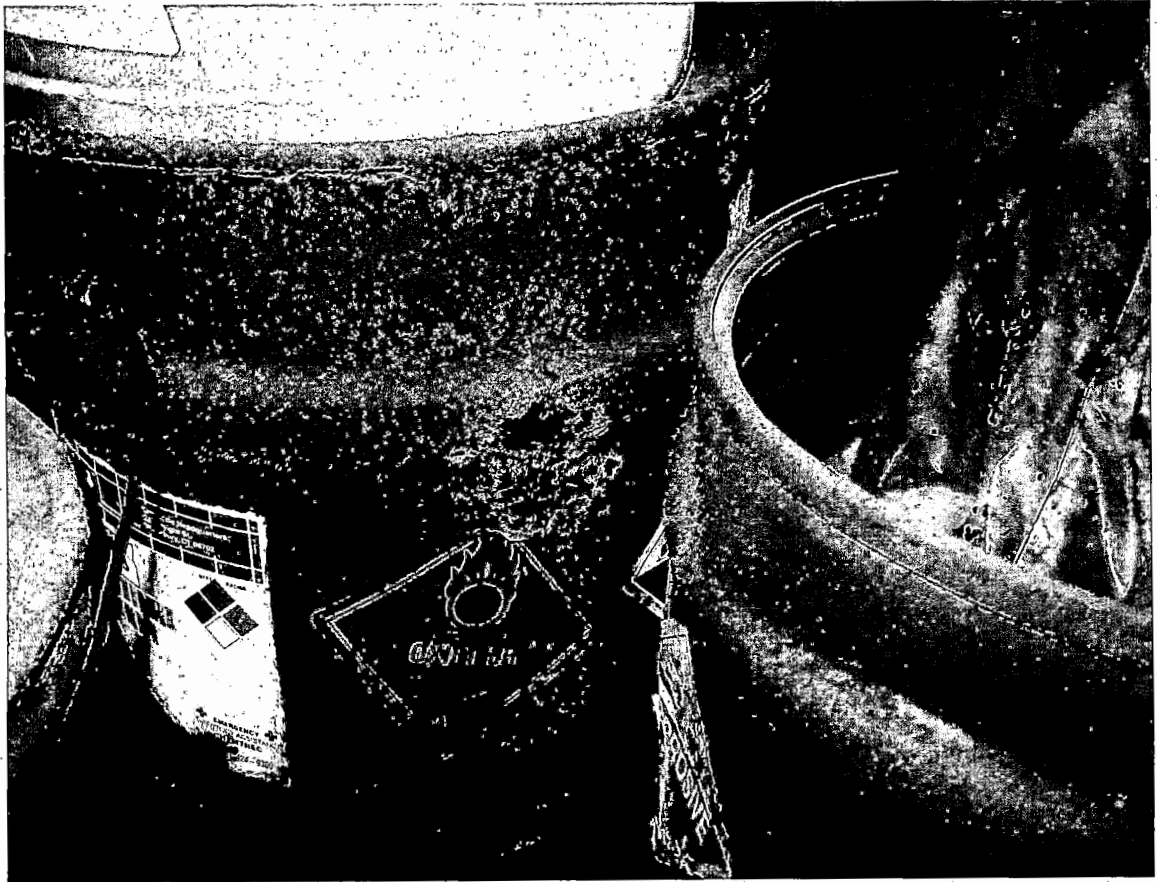
Photograph #5

SHWMB representatives observed an extremely rusted container with a manufacturer's (MacDermid) product label reading "Iridite" (Container #83). The photograph shows a hole in the side of the container.

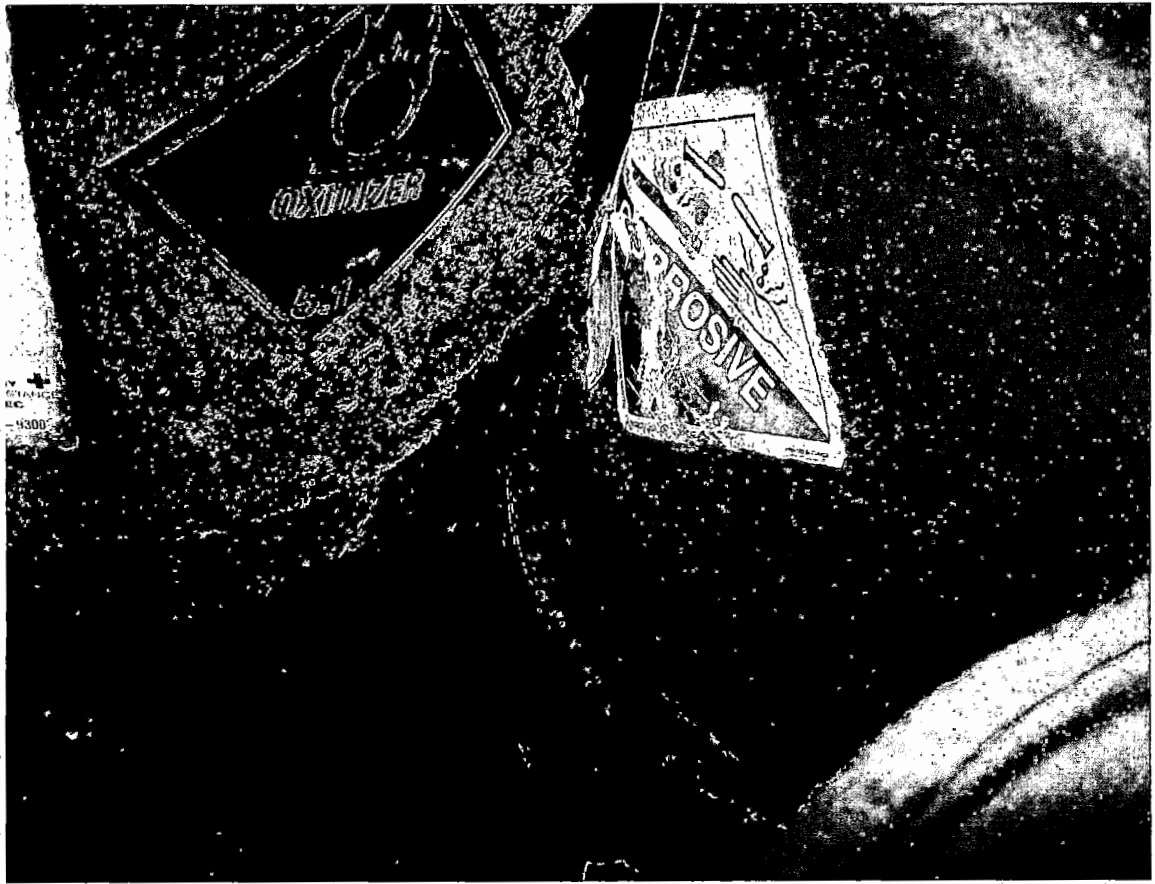
Photograph #6

SHWMB representatives observed an extremely rusted container with a manufacturer's (MacDermid) product label reading "Iridite" (Container #83). The photograph shows a black liquid leaking from the bottom of the container on the left. The photograph also shows several rusted containers containing an unknown material in the immediate vicinity.

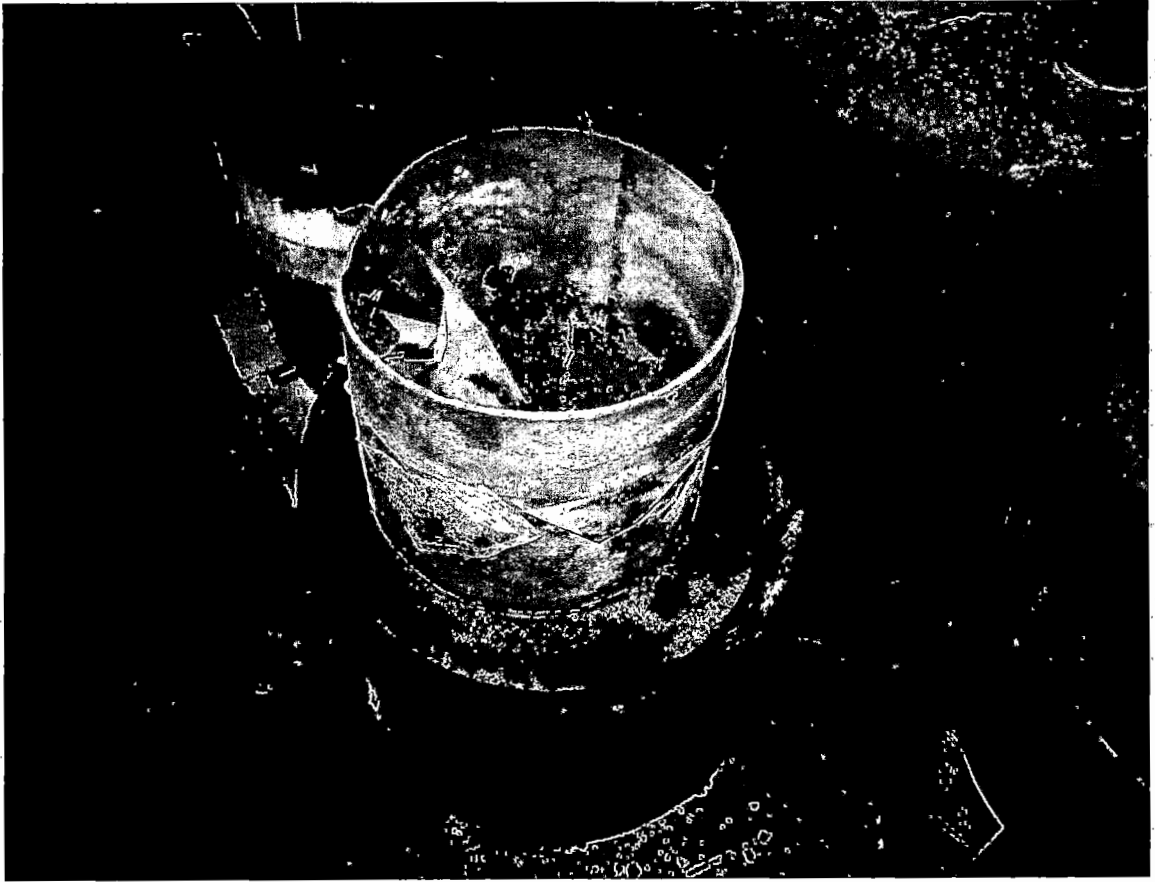
Photograph #7

SHWMB representatives observed several other extremely rusted containers on the wooden pallet holding Containers #72-85. The container on top is also open and contains an unknown corrosive material.

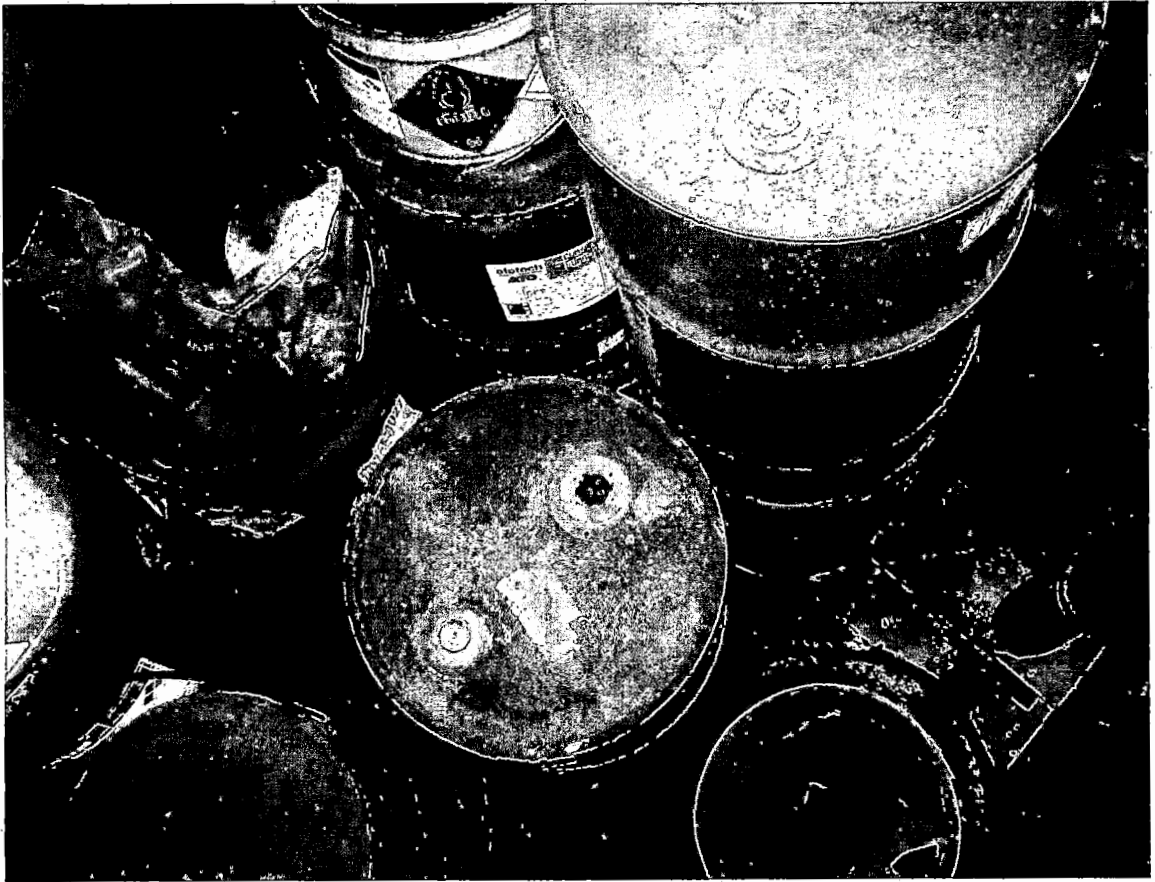
Photograph #8

Overview of Containers #72-45 detailed in Photographs #3-7 above.

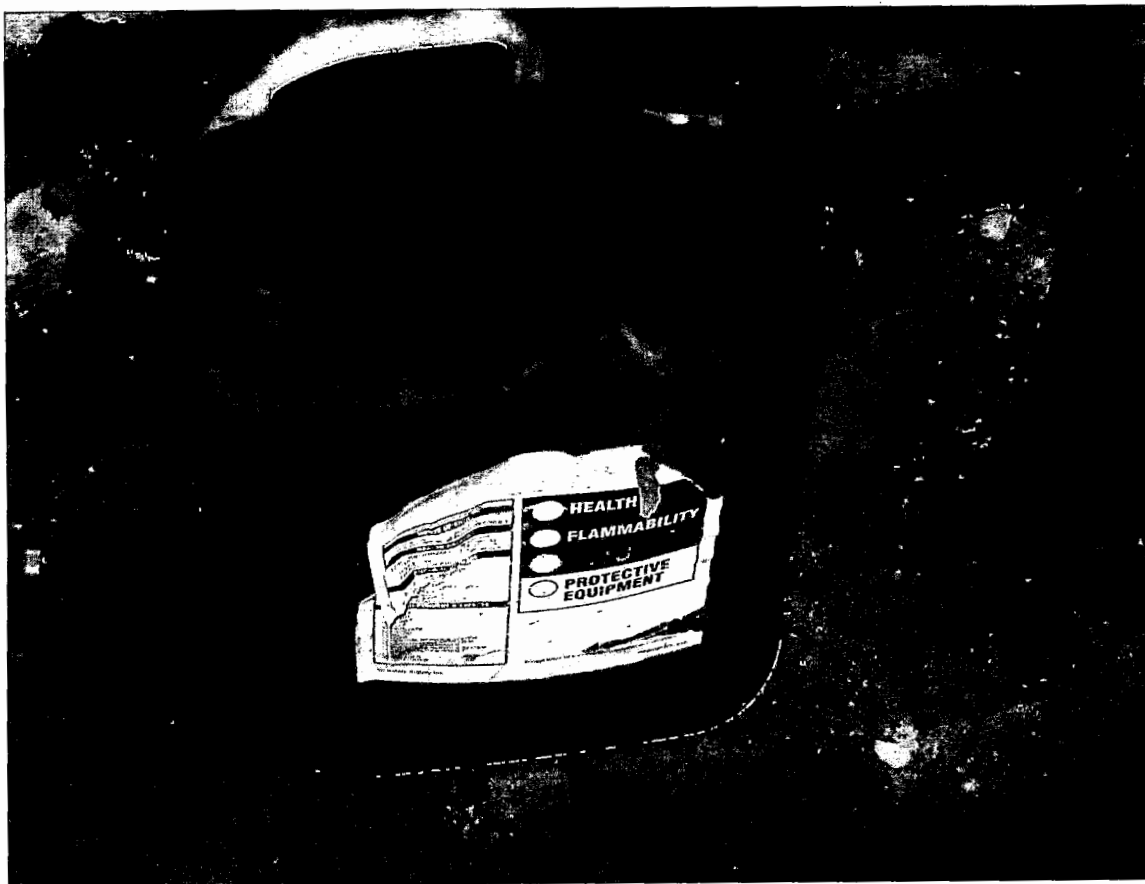
Photograph #9

SHWMB representatives observed an approximately 2.5-gallon poly jug containing an unknown liquid. (Container #40)

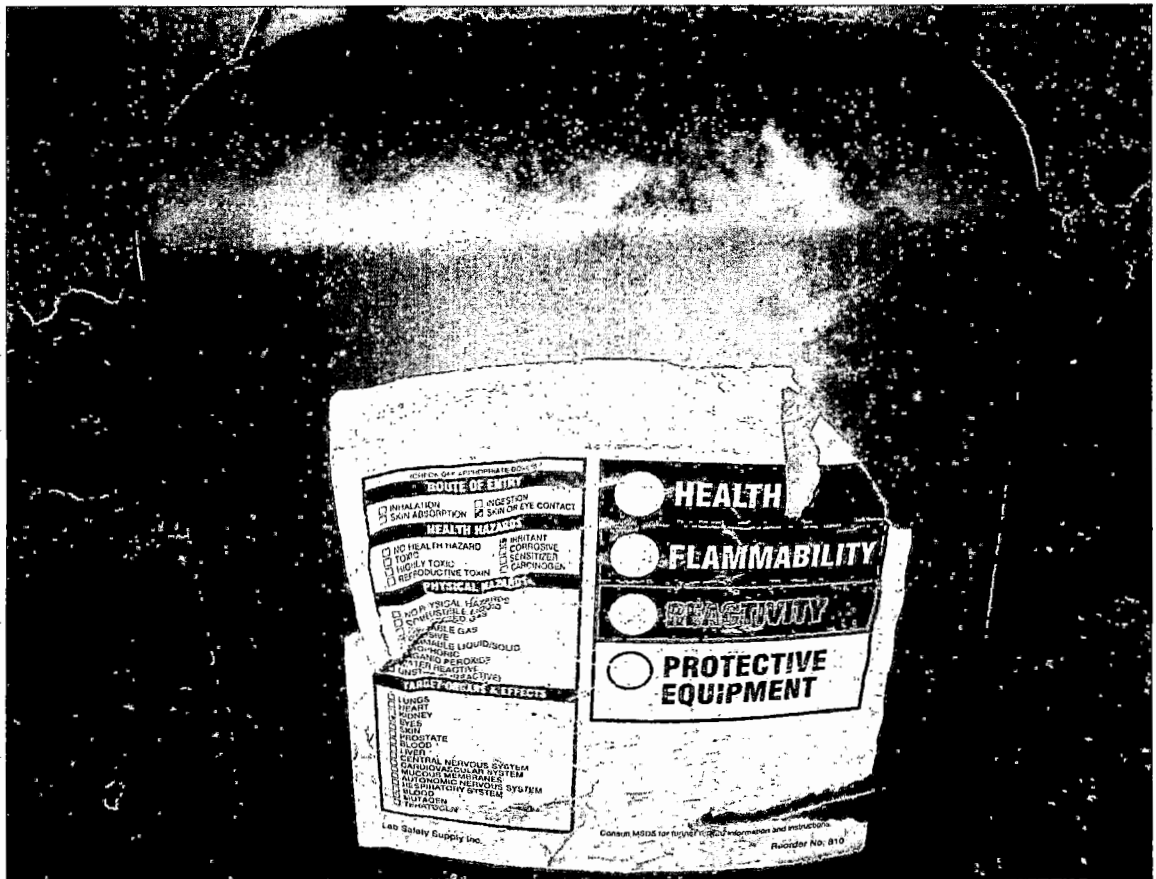
Photograph #10

Zoom in on the container identified in Photograph #7 showing the container is not labeled to identify its contents.

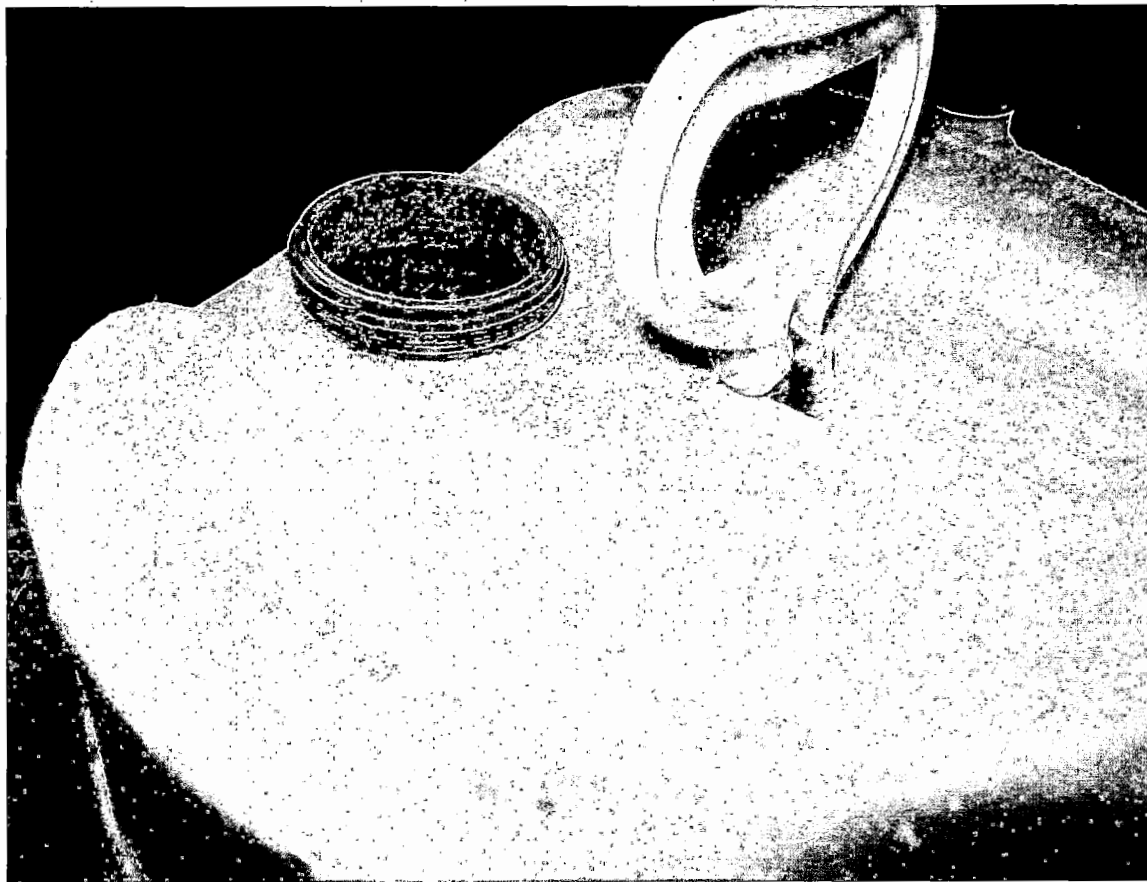
Photograph #11

SHWMB representatives observed a 2.5-gallon poly jug containing an unknown material. This container was open and observed on the pallet holding Containers #30-40.

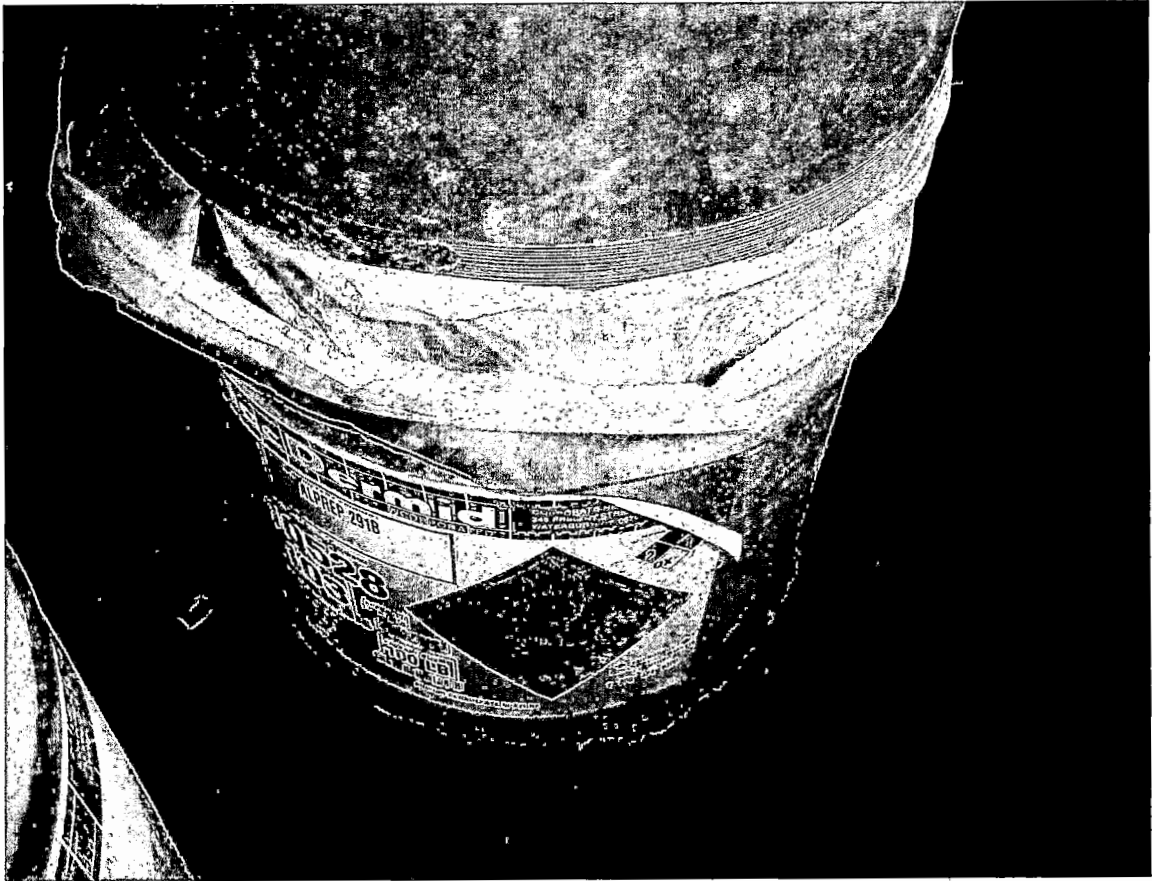
Photograph #12

SHWMB representatives observed a 10-gallon fiber drum labeled with a manufacturer's product label as containing "MacDermid ALPREP 291B." The bottom of the fiber container is deteriorated and the bottom of the container is turning green.

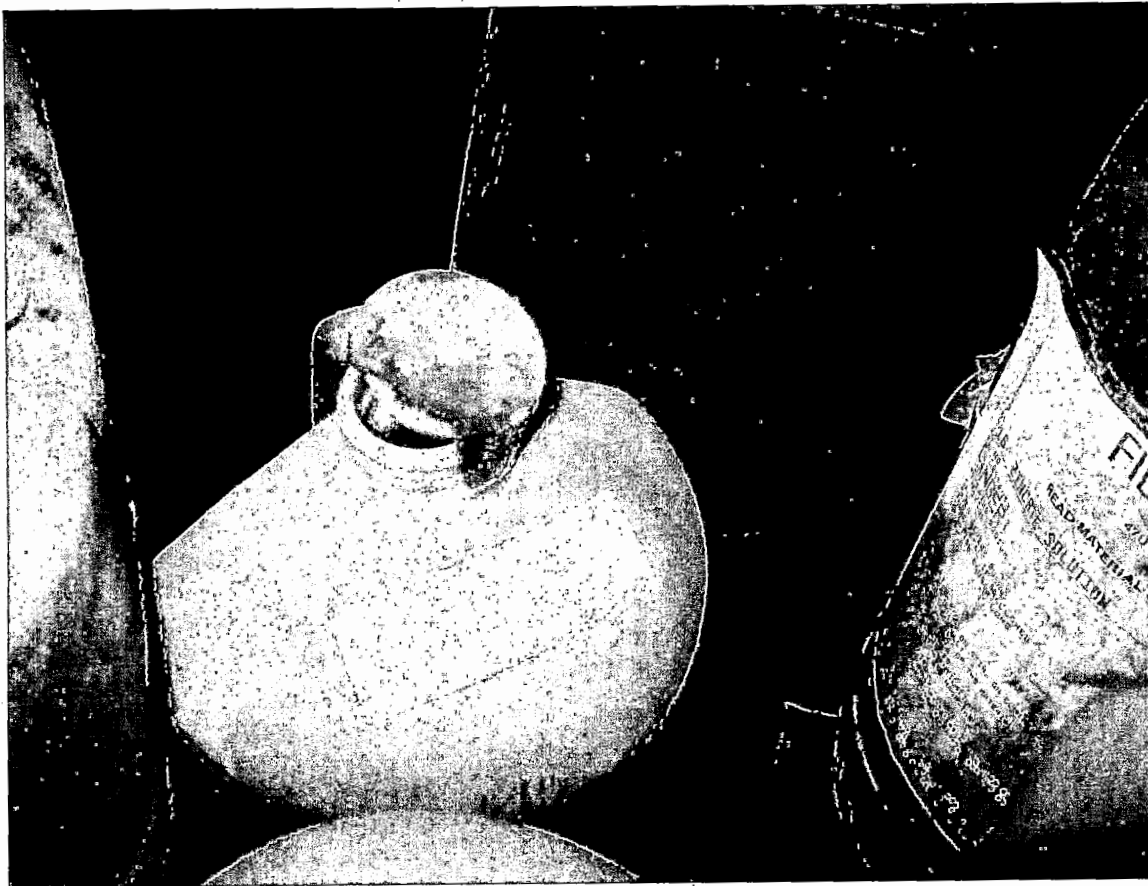
Photograph #15

SHWMB representatives observed a 1-gallon poly jug (Container #54). The label on the container was illegible and the lid was broken.

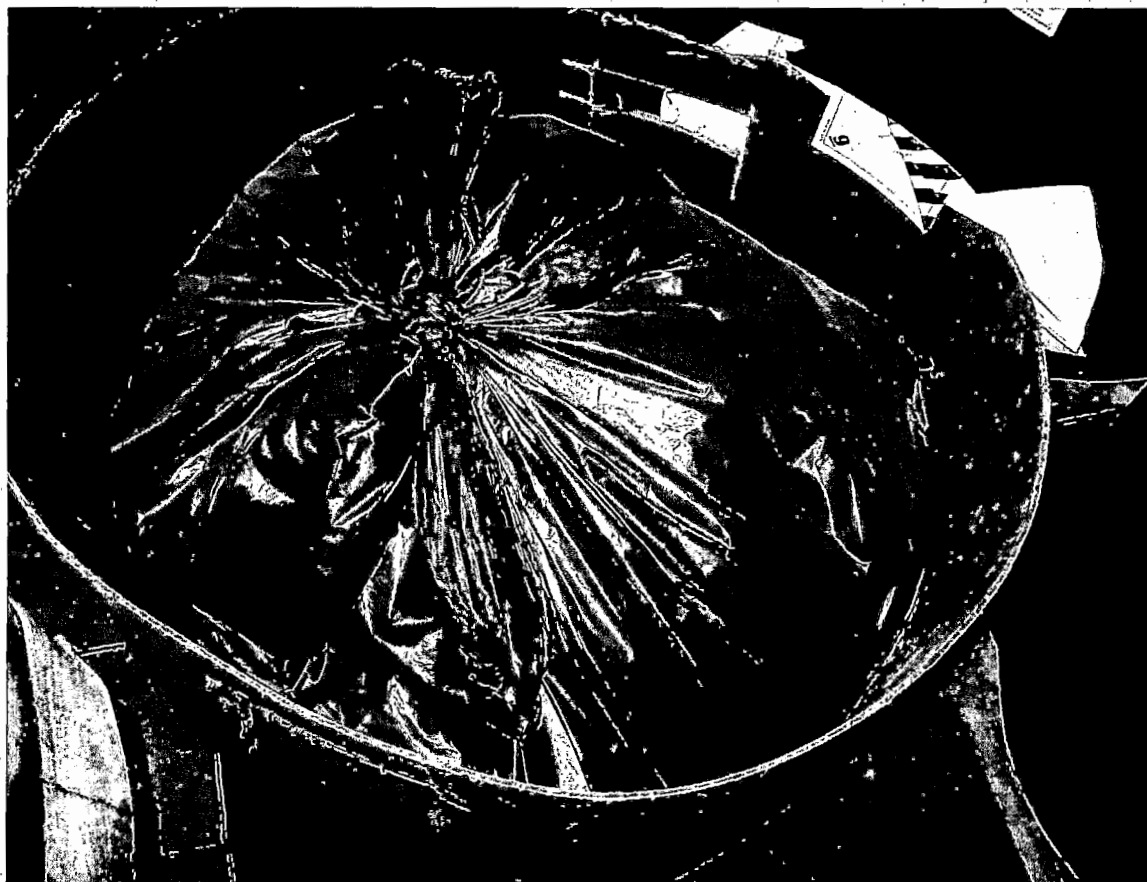
Photograph #16

SHWMB representatives observed an approximately 30-gallon poly drum with the top cut off and handles cut into the side (Container #45). The container is used to accumulate solidified gold plating bath solution, which is sent off-site for gold reclamation. This container was observed during the July 1, 2008 FUI without a plastic liner and open.

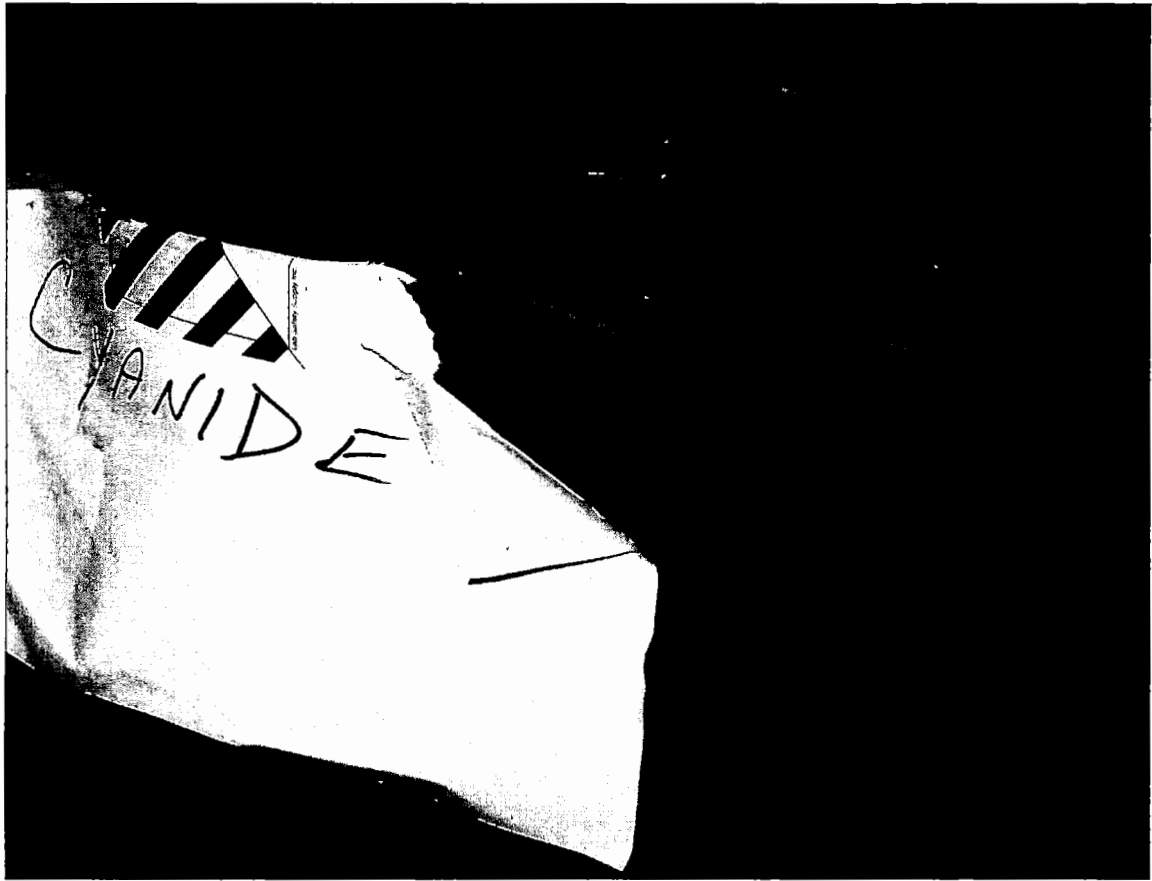
Photograph #17

Close-up of the label for the container described in Photograph #16.

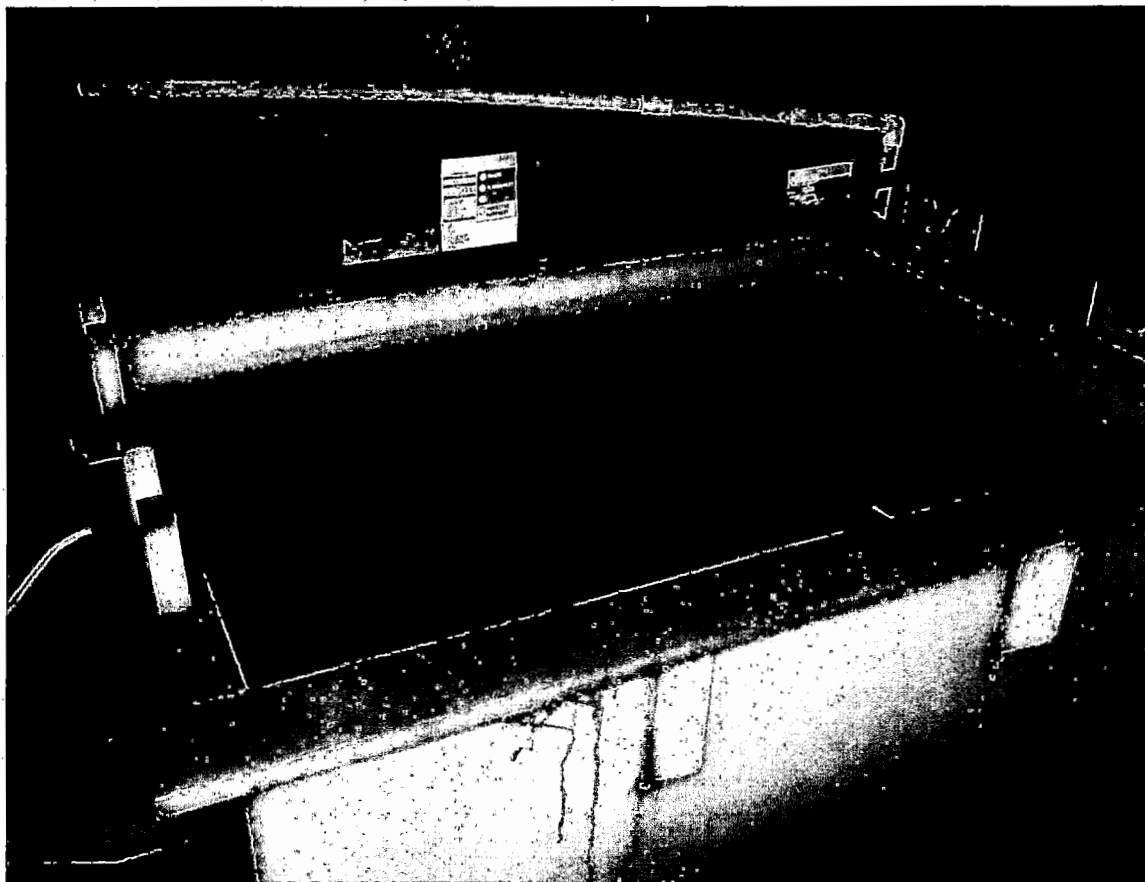
Photograph #18

SHWMB representatives observed an open tank of nitric acid. The facility representatives had previously stated that this material, which was also observed during the July 1, 2008 FUI, was not a waste.

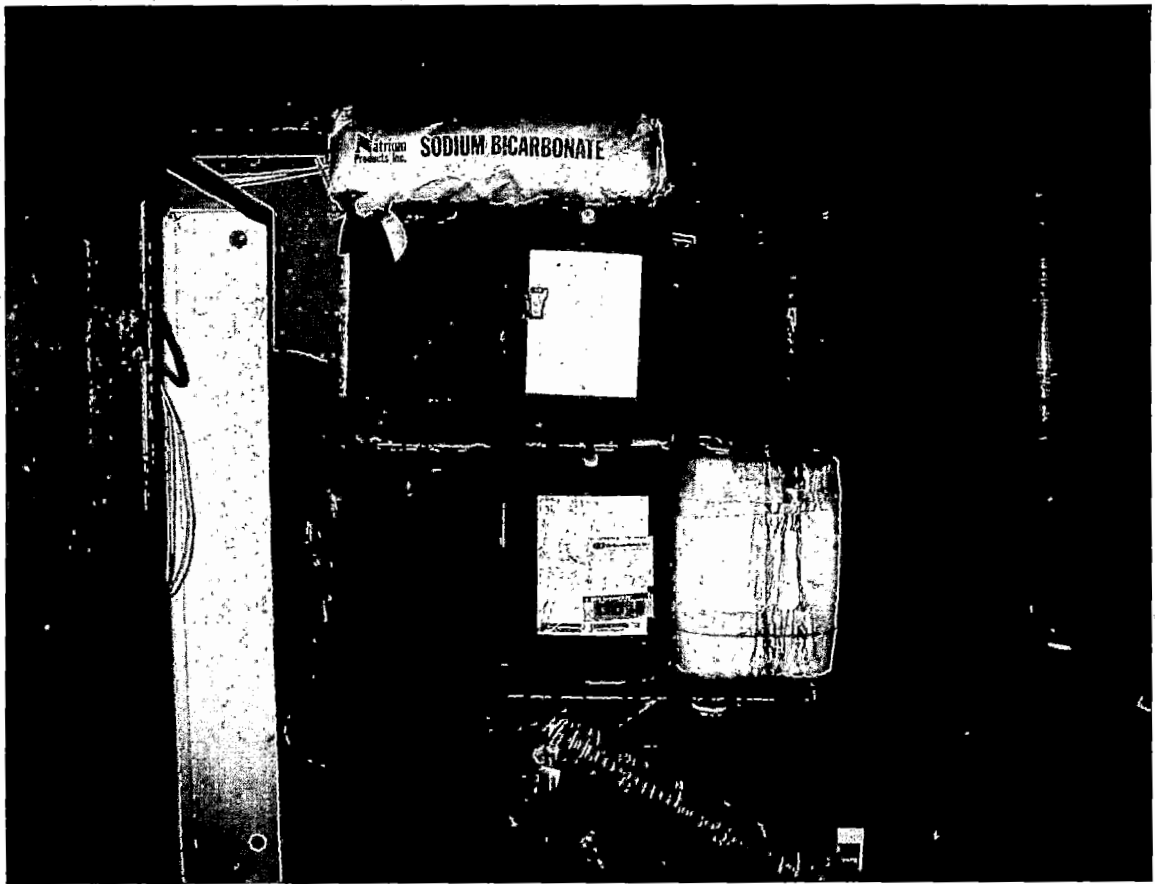
Photograph #21

SHWMB representatives observed several containers in Row 7 (Containers #150-177). The labels on the smaller containers on top are either illegible (with the exception of the bag of sodium bicarbonate) or SHWMB representatives could not access the containers and the contents are unknown.

The remaining 15 – 55 gallon drums also could not be accessed by SHWMB representatives to determine their contents.

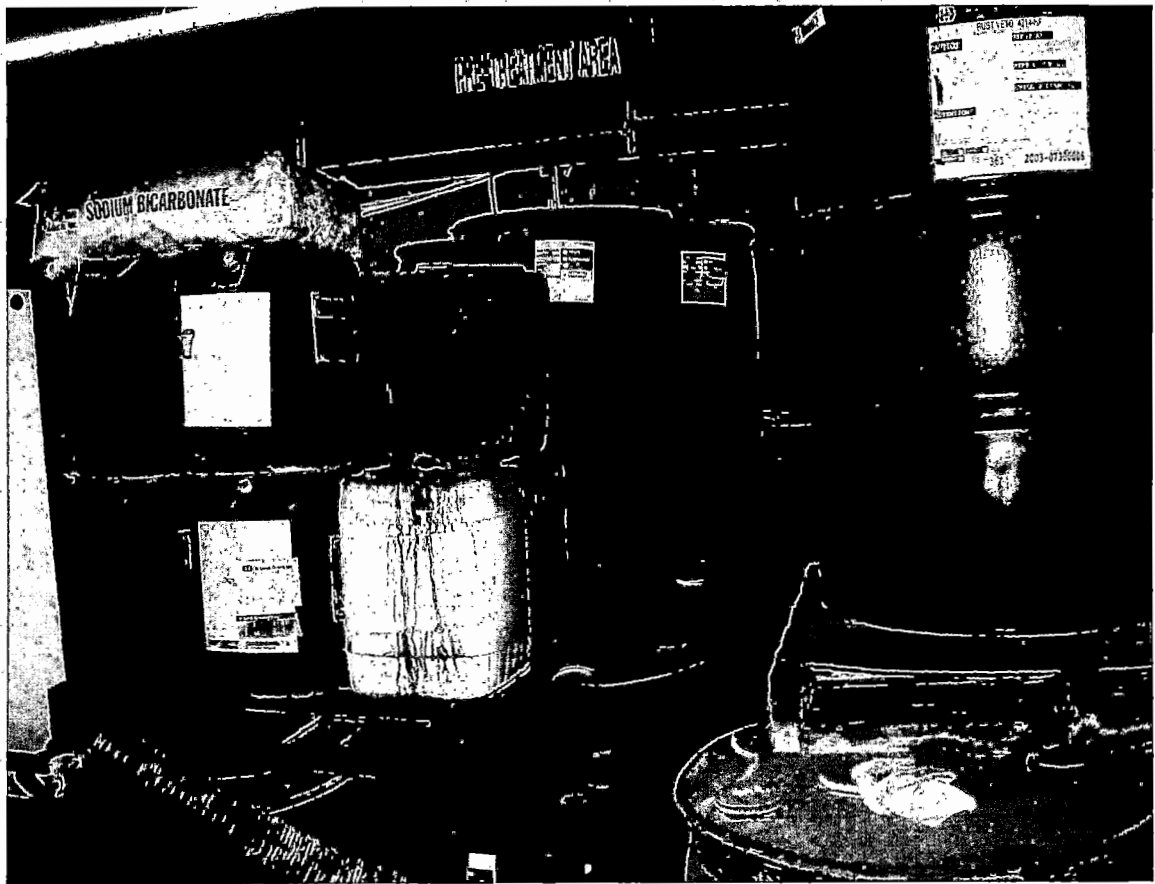
Photograph #22

Different angle of Photograph #21.

SHWMB representatives observed several containers in Row 7 (Containers #150-177). The labels on the smaller containers on top are either illegible (with the exception of the bag of sodium bicarbonate) or SHWMB representatives could not access the containers and the contents are unknown.

The remaining 15 – 55 gallon drums also could not be accessed by SHWMB representatives to determine their contents.

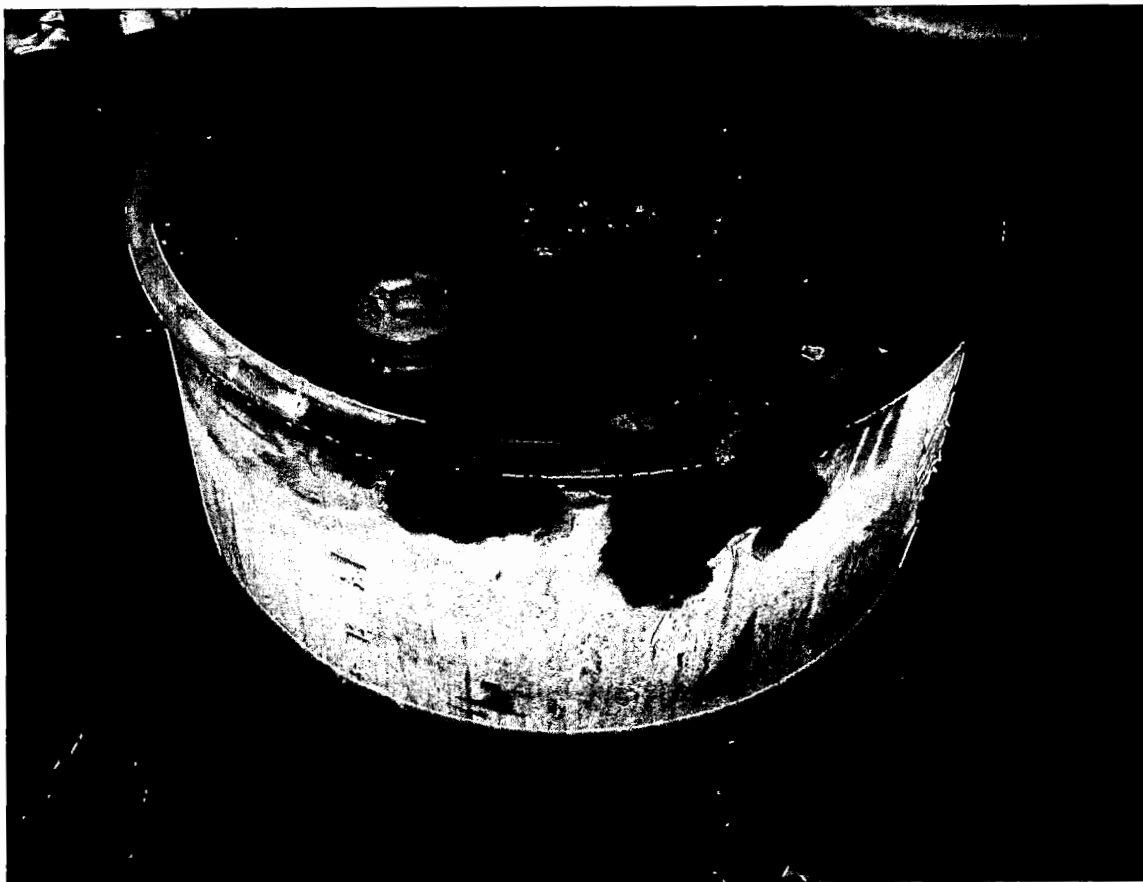
Photograph #23

SHWMB representatives observed an unknown yellow-greenish liquid on top of this 55-gallon poly drum (Container #186). The container was not labeled and its contents are unknown.

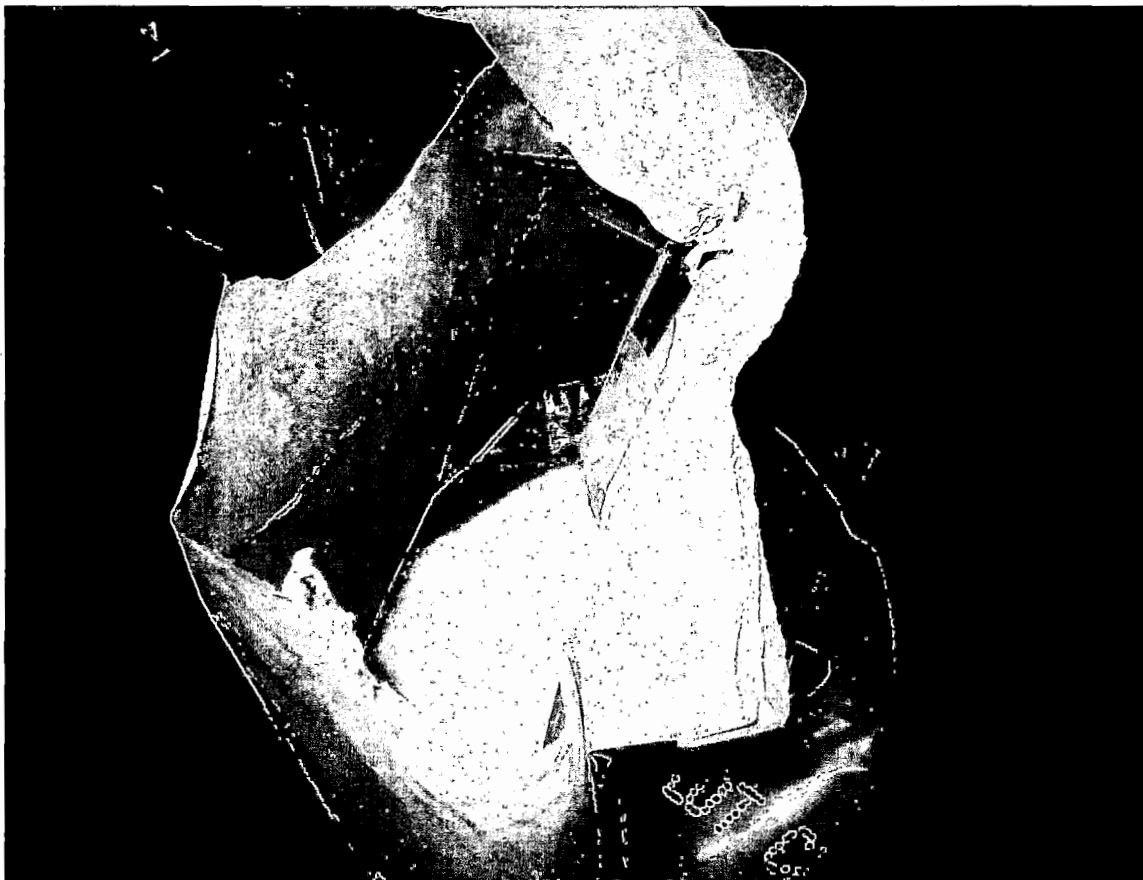
Photograph #24

SHWMB representatives observed an open 25 lb bag of ammonium bifluoride (Container #192). According to the MSDS, ammonium bifluoride is incompatible with acids and alkalis.

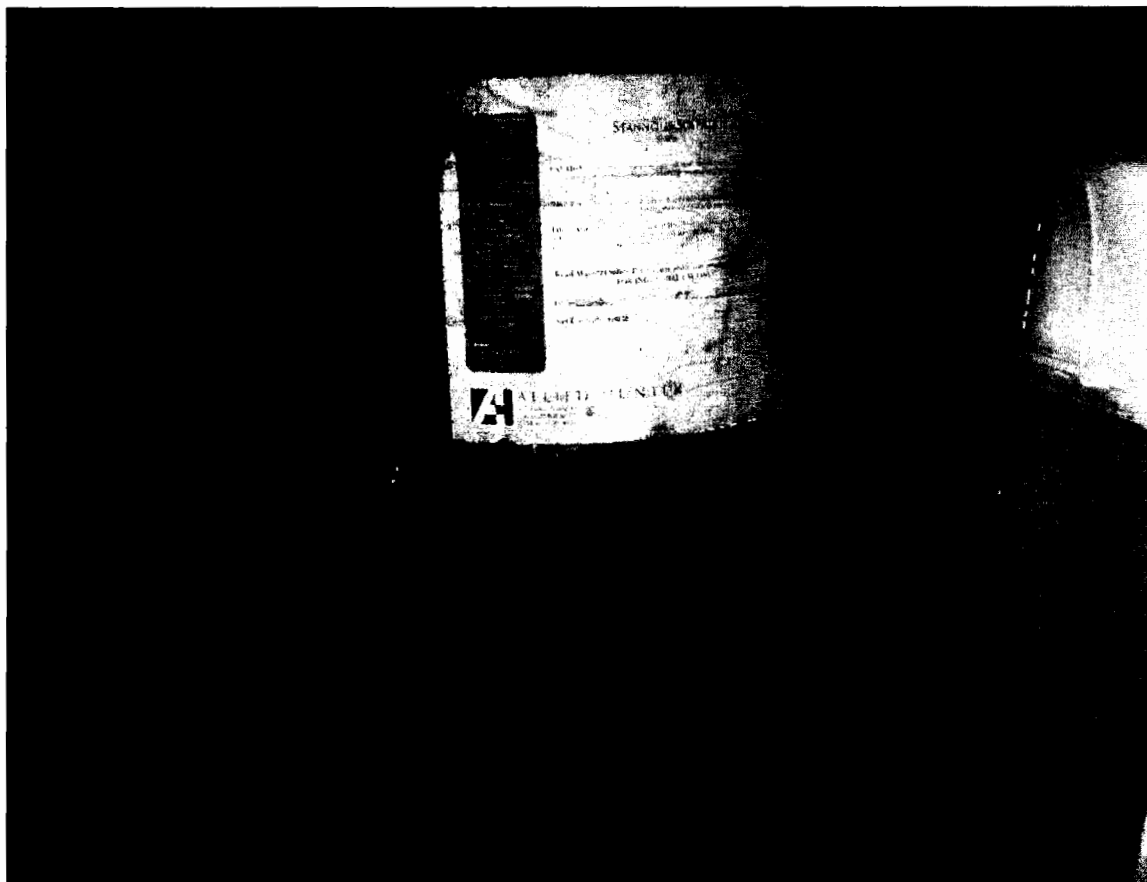
Photograph #25

SHWMB representatives observed a 5-gallon fiber drum with a manufacturer's product label indicating it contained stannous sulfate. The container had water marks and was rusted at the bottom.

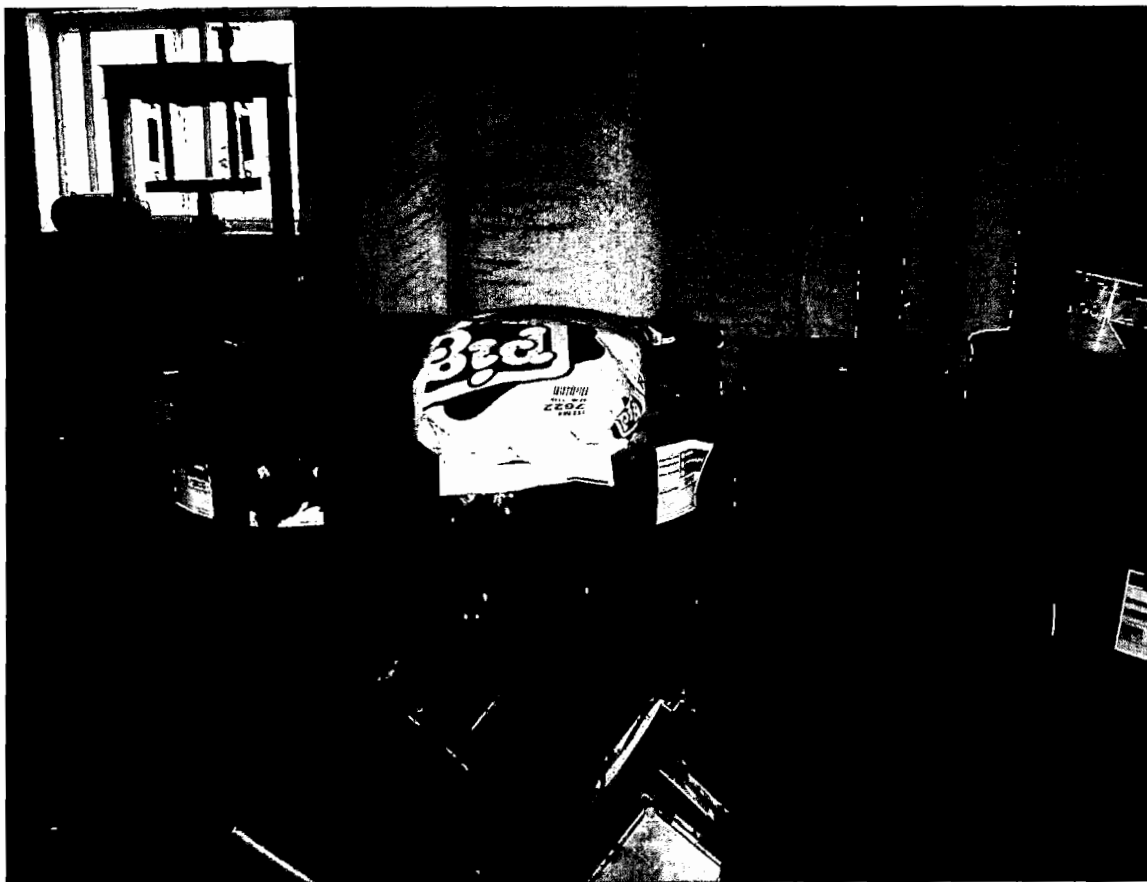
Photograph #26

Overview of containers observed in Row 9 (Containers #208-215). The two 55-gallon drums in the right of the picture are unlabeled and rusted. The contents of all of the containers are also unknown.

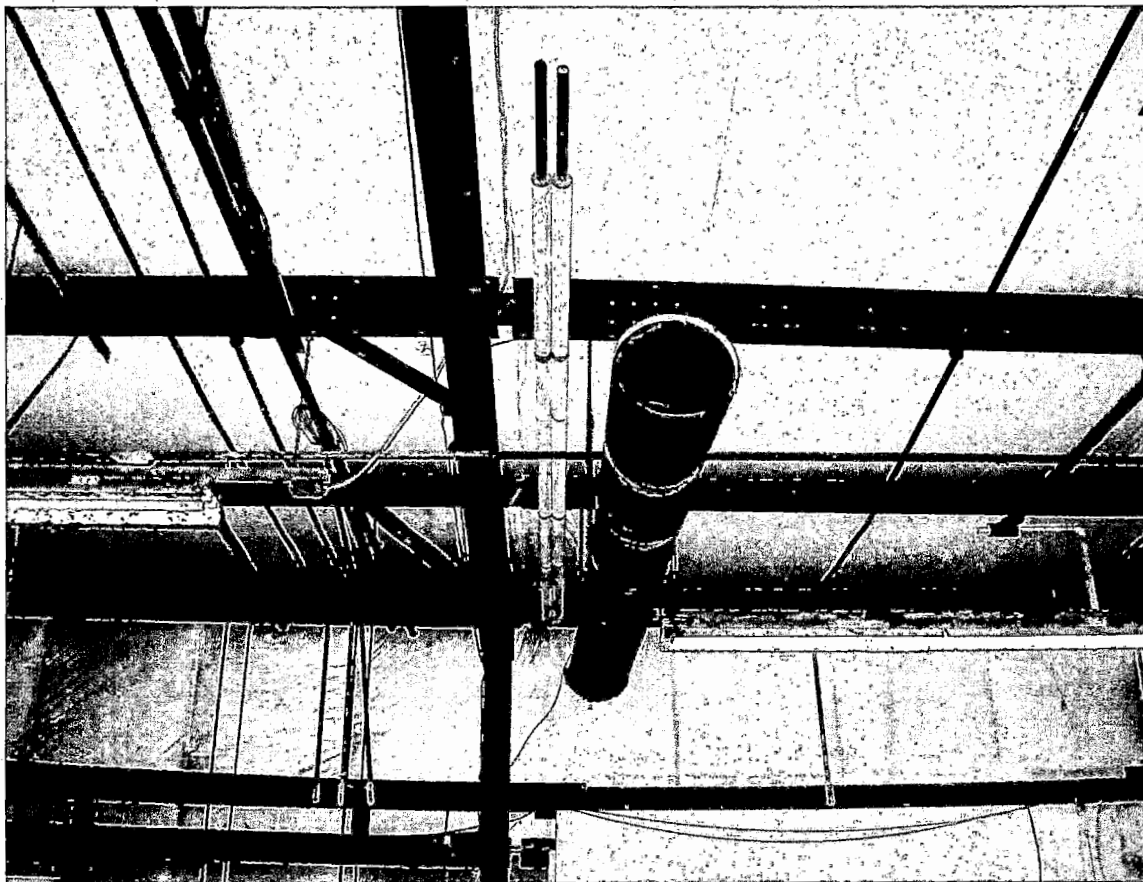
Photograph #29

SHWMB representatives observed open-ended piping/ductwork in the wall between the Drum/Container Storage Area and the Grinder/polisher.
